**Flood Control Project Maintenance
Levee Inspections**
LMA District Cover Sheet
Spring 2010 Levee Inspection Results

Reclamation District No. 2101 Blewett

Levee Inspection Report By Mile - Spring 2010

Waterway							Bank	Unit Miles	Inspection Start/End	Inspector
Unit No. 01 San Joaquin River							Left	3.20	04/27/2010 04/27/2010	John Paasch
LMR No.	Levee Mile		Category	Item	Location *	Rating **	Action/Comment	GPS Latitude/Longitude		Issue No.
	Start	End						Start	End	Photo
1	0.04	1.61	Earthen Levee	Vegetation	WS	M	Control annual grass and weeds on the levee slopes and easements.	37.657742 ° -121.253894 °	37.651563 ° -121.233689 °	6 Y
2	0.04	0.17	Earthen Levee	Vegetation	LS	M	Control annual grass and weeds on the levee slopes and easements.	37.657743 ° -121.253894 °	37.656928 ° -121.252015 °	4 Y
3	0.04	2.79	Earthen Levee	Vegetation	WS	C	Remove the wild growth other than native grasses from the levee slopes. Inspector Comments: Last Fall, Fish & Game stated they would now allow vegetation maintenance on water side. Significant improvement has been made since on the waterside.	37.657587 ° -121.254147 °	37.641538 ° -121.229748 °	2

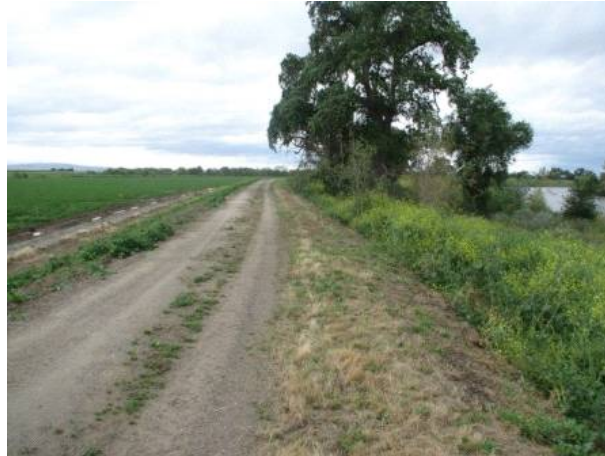
Levee Mile Report Line	1
Start Levee Mile	0.04
End Levee Mile	1.61
Location	Water Side
Category	Earthen Levee
Item	Vegetation
Vegetation on top 20' of waterside slope limits visibility. Photo at LM 1.6	
jpaasch_s_20100428_352.jpg

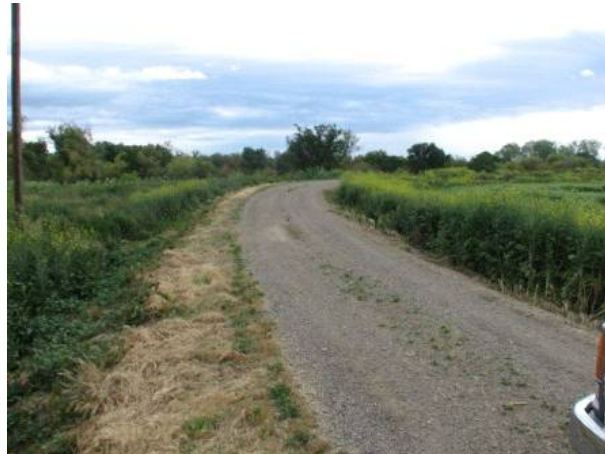
Levee Mile Report Line	2
Start Levee Mile	0.04
End Levee Mile	0.17
Location	Land Side
Category	Earthen Levee
Item	Vegetation
Annual grasses and weeds on levee slope.	
jpaasch_s_20100428_339.jpg

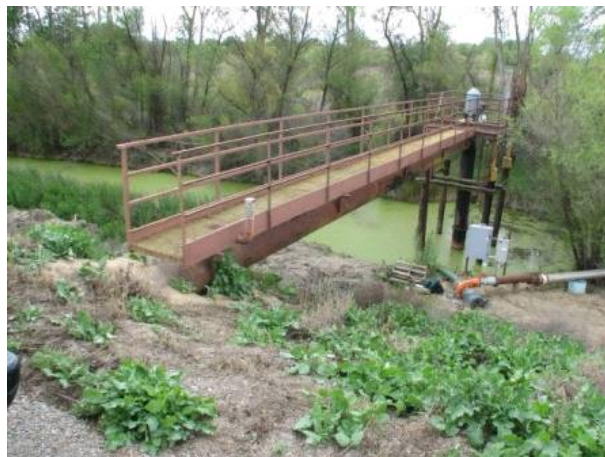
Levee Mile Report Line	7
Start Levee Mile	0.19
End Levee Mile	0.19
Location	Crown
Category	Earthen Levee
Item	Encroachments
Drainage discharge under levee crown.	
jpaasch_s_20100428_340.jpg

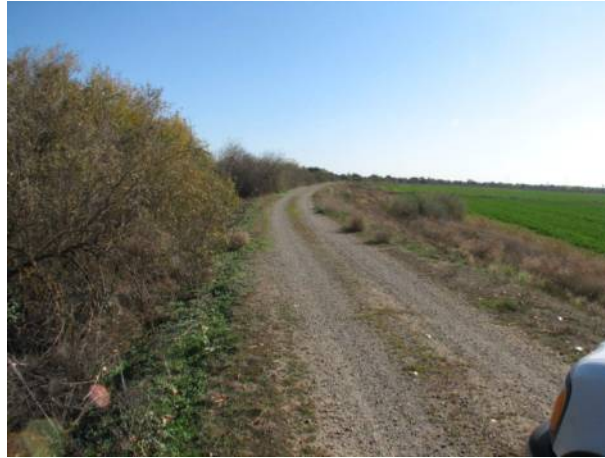
Levee Mile Report Line	9
Start Levee Mile	0.49
End Levee Mile	0.49
Location	Water Side
Category	Earthen Levee
Item	Trim / Thin Trees
Trees on top 20-ft of waterside slope block access and visibility.	
jpaasch_s_20100330_133.jpg

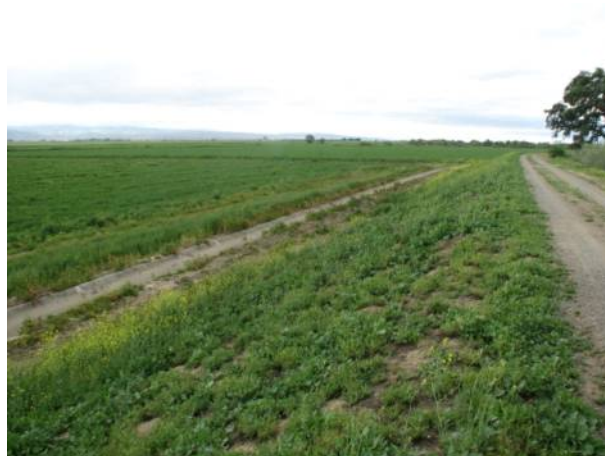
Levee Mile Report Line	11
Start Levee Mile	0.76
End Levee Mile	1.80
Location	Land Side
Category	Earthen Levee
Item	Encroachments
Concrete ditch near landside toe.	
jpaasch_s_20100428_341.jpg

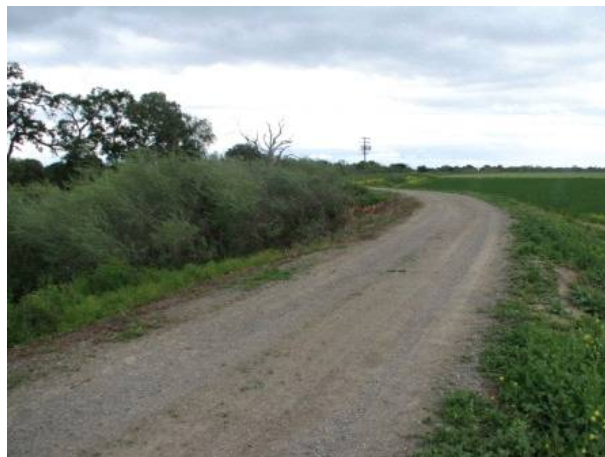
Levee Mile Report Line	18
Start Levee Mile	1.61
End Levee Mile	1.82
Location	Water Side
Category	Earthen Levee
Item	Vegetation
Obstructive vegetation on waterside slope within 20' of crown.	
jpaasch_s_20100428_343.jpg

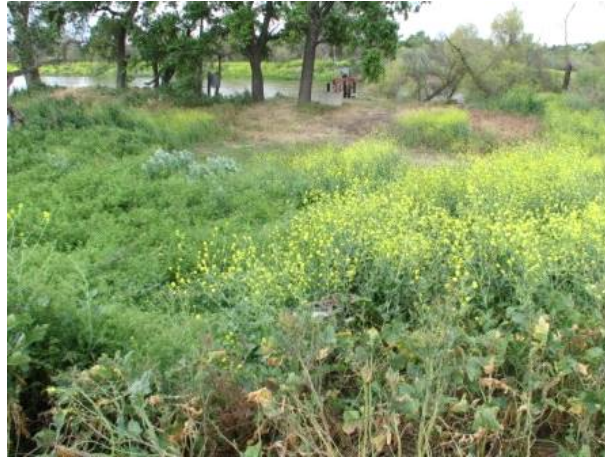
jpaasch_s_20100428_342.jpg

Levee Mile Report Line	19
Start Levee Mile	1.61
End Levee Mile	1.61
Location	Water Side
Category	Earthen Levee
Item	Encroachments

Photo of pump in background and CMP riser with valve in foreground.

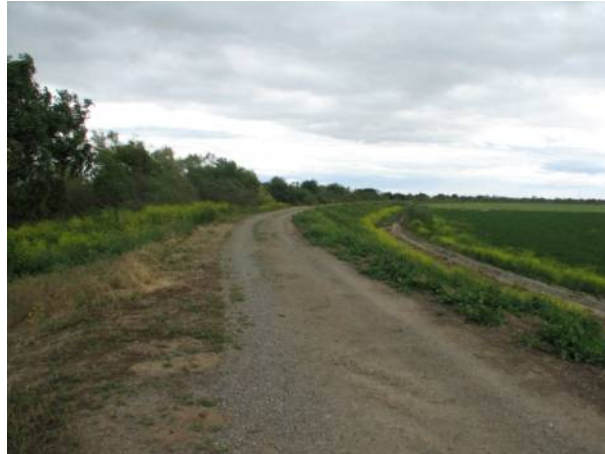
jpaasch_s_20100428_344.jpg

Levee Mile Report Line	20
Start Levee Mile	1.62
End Levee Mile	1.84
Location	Land Side
Category	Earthen Levee
Item	Vegetation

Partially obstructive annual grasses on levee slope.

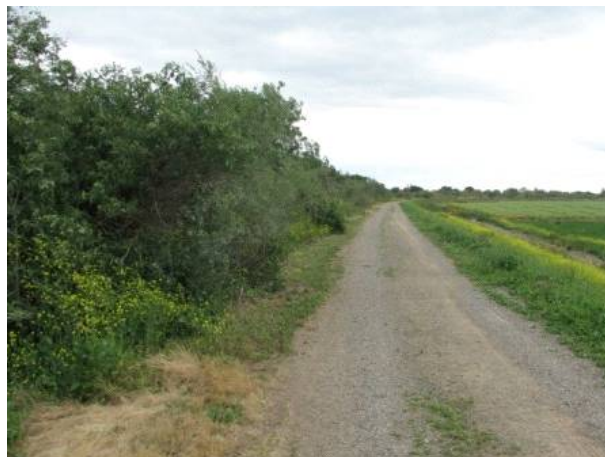
jpaasch_s_20100428_347.jpg

Levee Mile Report Line	21
Start Levee Mile	1.62
End Levee Mile	1.84
Location	Water Side
Category	Earthen Levee
Item	Trim / Thin Trees

Trees on top 20' of waterside slope obstruct access and visibility.

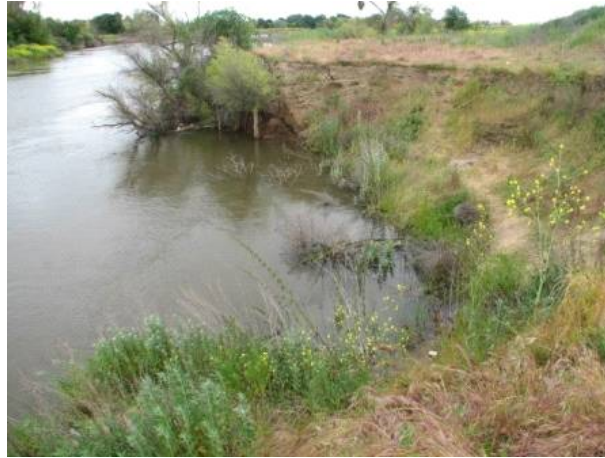
jpaasch_s_20100428_345.jpg

Levee Mile Report Line	23
Start Levee Mile	1.91
End Levee Mile	2.00
Location	Water Side
Category	Supplemental
Item	DWR Erosion Survey

Spring 2010 photo of erosion site. San Joaquin river is eroding the existing berm.

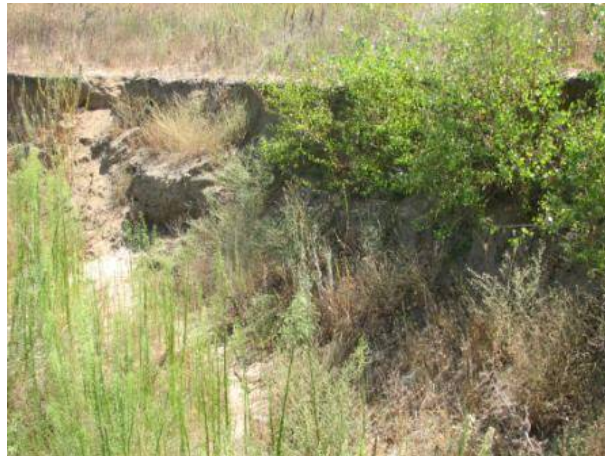
SJR2009_RM73.92a.JPG

Levee Mile Report Line	23
Start Levee Mile	1.91
End Levee Mile	2.00
Location	Water Side
Category	Supplemental
Item	DWR Erosion Survey

2009: recommend annual assessment and monitoring of critical erosion site, per CLRO CES Evaluation 2008 Report; an eddy has formed, eroding bank and intruding into the levee prism; site # same as RM76.3,LM1.89; previously rated "U" [2009 SiteID:RD2101U1RM73.92]

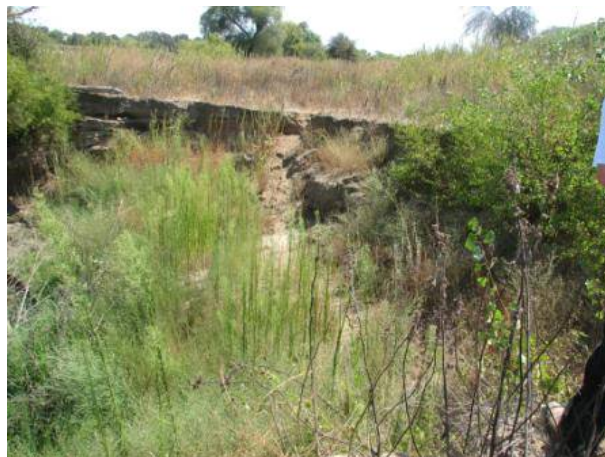
SJR2009_RM73.92b.JPG

Levee Mile Report Line	23
Start Levee Mile	1.91
End Levee Mile	2.00
Location	Water Side
Category	Supplemental
Item	DWR Erosion Survey

2009: recommend annual assessment and monitoring of critical erosion site, per CLRO CES Evaluation 2008 Report; an eddy has formed, eroding bank and intruding into the levee prism; site # same as RM76.3,LM1.89; previously rated "U" [2009 SiteID:RD2101U1RM73.92]

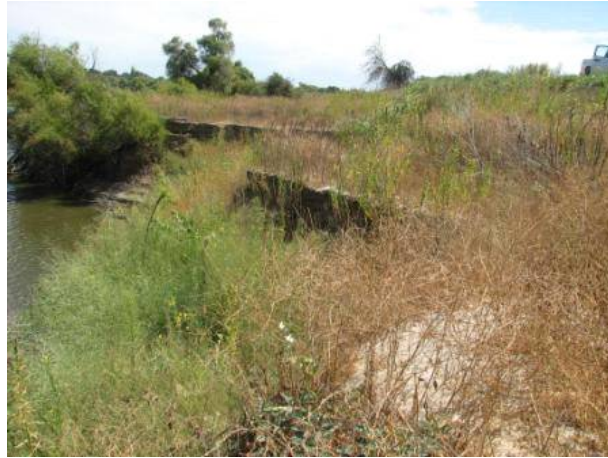
SJR2009_RM73.92c.JPG

Levee Mile Report Line	23
Start Levee Mile	1.91
End Levee Mile	2.00
Location	Water Side
Category	Supplemental
Item	DWR Erosion Survey

2009: recommend annual assessment and monitoring of critical erosion site, per CLRO CES Evaluation 2008 Report; an eddy has formed, eroding bank and intruding into the levee prism; site # same as RM76.3,LM1.89; previously rated "U" [2009 SiteID:RD2101U1RM73.92]

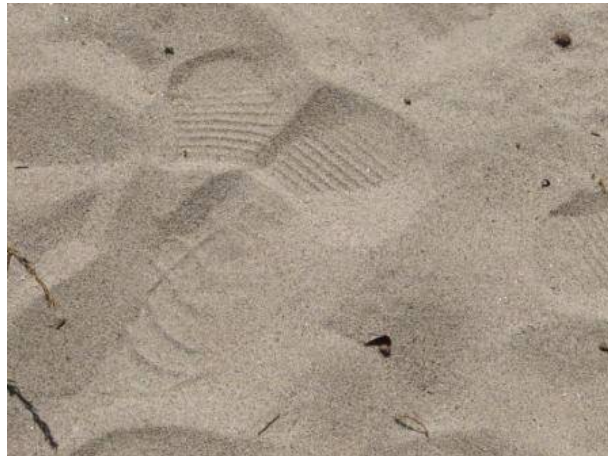
SJR2009_RM73.92e.JPG

Levee Mile Report Line	23
Start Levee Mile	1.91
End Levee Mile	2.00
Location	Water Side
Category	Supplemental
Item	DWR Erosion Survey

2009: recommend annual assessment and monitoring of critical erosion site, per CLRO CES Evaluation 2008 Report; an eddy has formed, eroding bank and intruding into the levee prism; site # same as RM76.3,LM1.89; previously rated "U" [2009 SiteID:RD2101U1RM73.92]

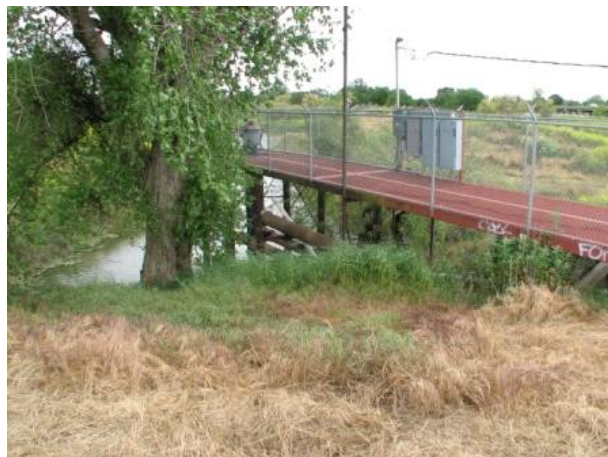
jpaasch_s_20100428_348.jpg

Levee Mile Report Line	31
Start Levee Mile	2.74
End Levee Mile	2.74
Location	Water Side
Category	Earthen Levee
Item	Encroachments

Irrigation intake near Maze Blvd.

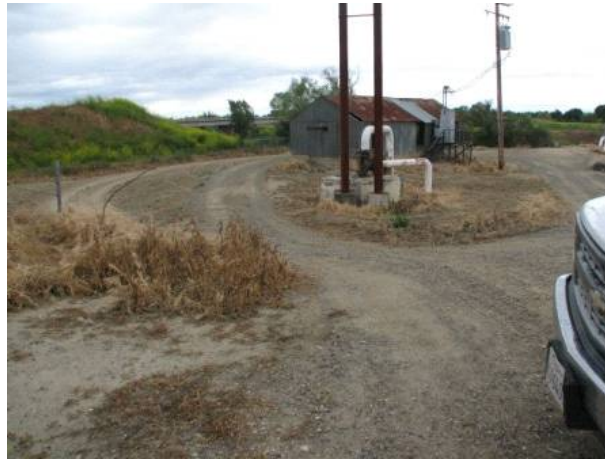
jpaasch_s_20100428_349.jpg

Levee Mile Report Line	32
Start Levee Mile	2.89
End Levee Mile	2.89
Location	Water Side
Category	Earthen Levee
Item	Encroachments

Risers on waterside berm and risers along road leading to levee indicate presence of pipe penetration.

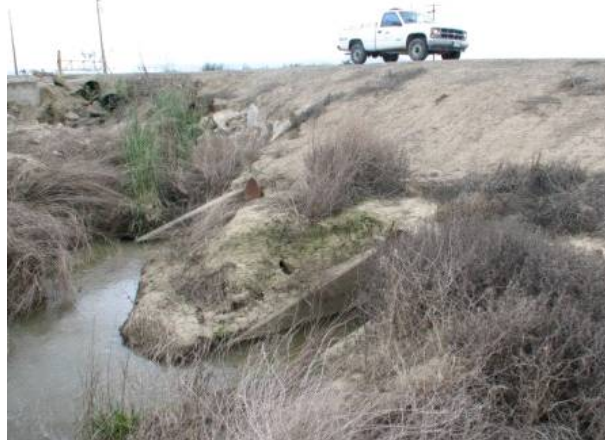
jpaasch_s_20100428_350.jpg

Levee Mile Report Line	33
Start Levee Mile	2.91
End Levee Mile	2.91
Location	Water Side
Category	Earthen Levee
Item	Encroachments

Drainage discharge to San Joaquin River.

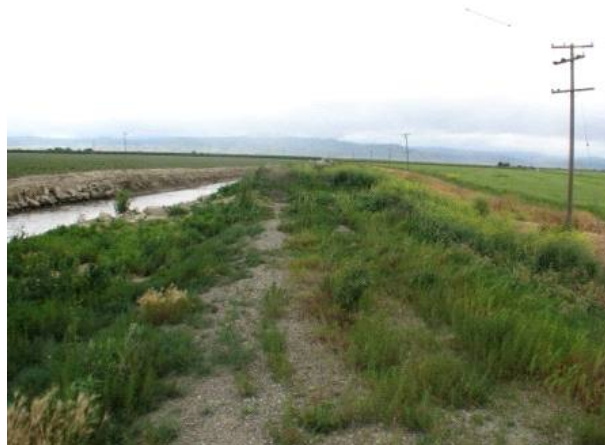
jpaasch_s_20100428_351.jpg

Levee Mile Report Line	34
Start Levee Mile	2.92
End Levee Mile	3.20
Location	Land Side
Category	Earthen Levee
Item	Vegetation

Vegetation on crown and slopes needs maintenance for access and visibility.

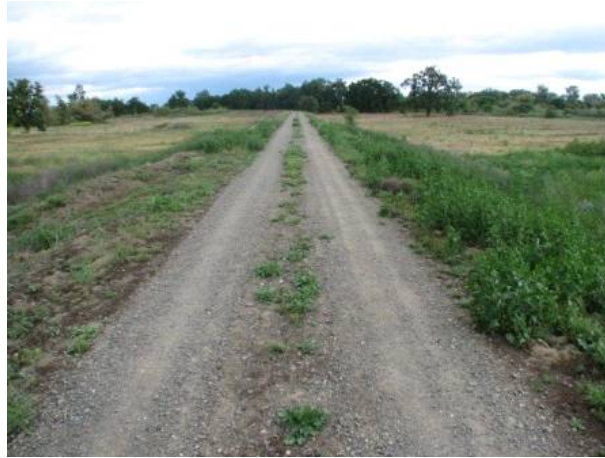
Levee Mile Report Line	1
Start Levee Mile	0.07
End Levee Mile	0.10
Location	Water Side
Category	Earthen Levee
Item	Vegetation
Broad leaf vegetation on levee slope partially block visibility.	
jpaasch_s_20100428_338.jpg
